UNIVERSITÉ DU QUÉBEC EN OUTAOUAIS

CARACTÉRISATION DES INFRASTRUCTURES DE VOIRIE DANS LES FORÊTS PUBLIQUES ET PRIVÉES
DE L'OUTAOUAIS, QUÉBEC

MÉMOIRE

CECILIA SYDOR-ESTABLE

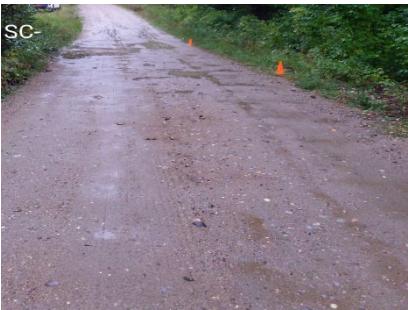
Degradation type	Description	Image
Potholes	Potholes are deep and often circular depressions in the road surface.

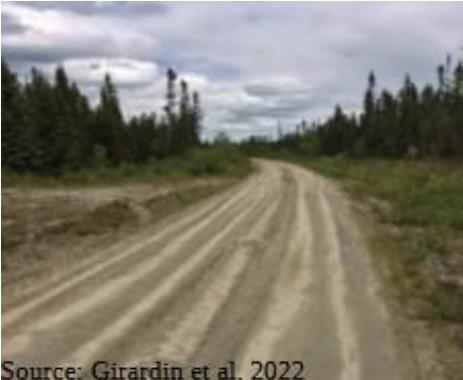
Ruts	Ruts are deep depressions in the road surface caused by water erosion and the transport of sediment away from the road surface. Ruts are distinct from furrows in that they consist of multiple rivets over the width of the road surface, and in the direction of vehicle travel.

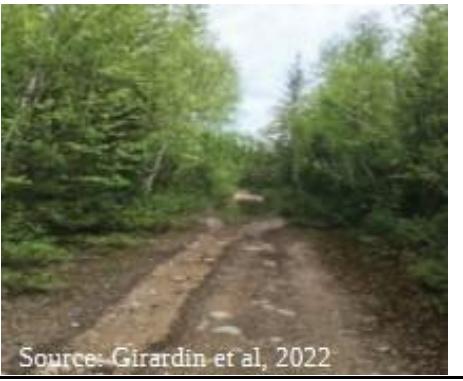
Source: Girardin et al, 2022
Furrows	Furrows are deep, parallel rivets which are caused by the repeated passage of vehicles. They are usually on the outermost left and right of the running lane surface and are the same width and distance apart as vehicle wheels.

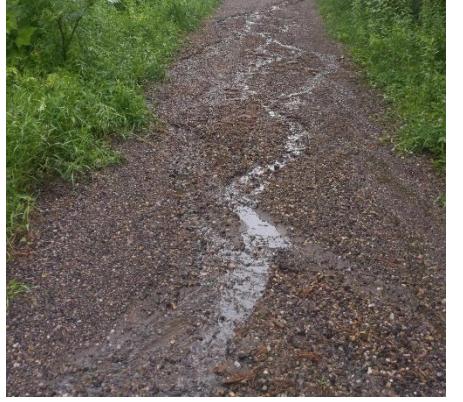
Source: Girardin et al, 2022
Erosion	In this case, erosion is defined as the transport of earth or surface material caused by the erosive action of water. This results in the repeated transport of sediment, even in small quantities, from the road surface to the nearby waterbody. It is represented by several deep or shallow channels, either in the longitudinal or transversal direction, distributed along the whole road surface.

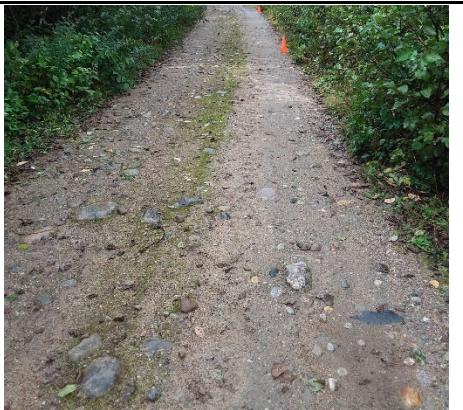
Sub-grade emergence	Sub-grade emergence refers to severe erosion, wherein the surface and base layer of the running lane are eroded, and foundation material is revealed. This is represented by exposed rocks on the running lane surface.

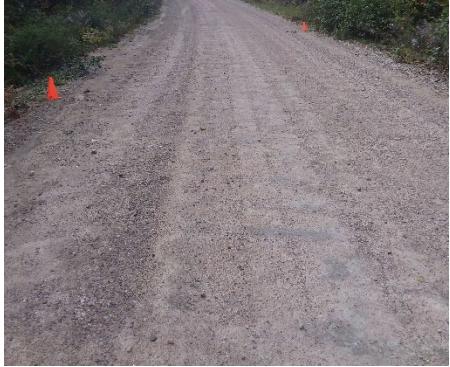
Wash-boarding	Wash-boarding consists of many small parallel bumps, which are perpendicular to one another along the running lane surface.

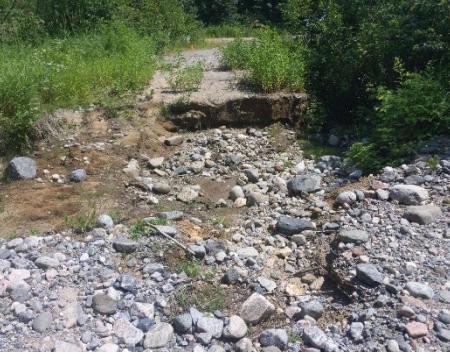
Complete road failure	Any degradation which leads to a complete break in road access. It could consist of the loss or collapse of a large portion of the road, such that it is no longer accessible.

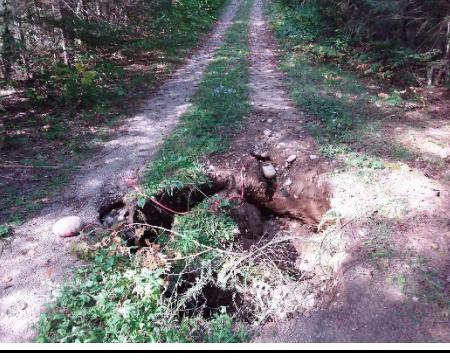
Partial road failure	Any degradation which leads to a partial break in road access. It could consist of the loss or collapse of a portion of the road, such that access is severely restricted or limited.
