UNIVERSITÉ DU QUÉBEC EN OUTAOUAIS

CARACTÉRISATION DES INFRASTRUCTURES DE VOIRIE DANS LES FORÊTS PUBLIQUES ET PRIVÉES
DE L'OUTAOUAIS, QUÉBEC

MÉMOIRE

CECILIA SYDOR-ESTABLE

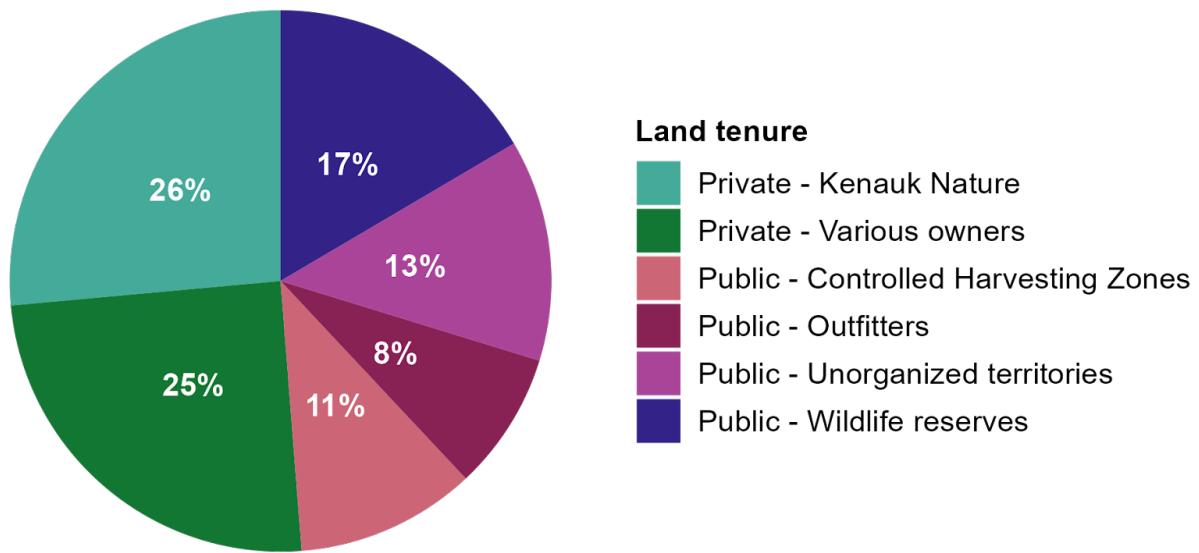
We assessed the state of 121 culverts: 59 culverts were located in public lands, and 62 were in private lands (32 in Kenauk Nature private forest and 30 in private forests under varied management; Fig. 2.2). Public lands have diversified management, which we were able to capture in our distribution of culverts evaluated within these varied land use types (Fig. 2.2). In terms of distribution throughout watersheds, 34 culverts were within the Saumon River catchment, 65 culverts within the Petite Nation River catchment, and 22 culverts within the Noire River catchment. Culverts assessed were between 25-270 cm in diameter and 25-243 cm in height, with an average of 106 cm for diameter, and 104 cm for height. The length ranged between 2.80 m and 23.1 m, with an average of 8.8 m. Culvert conduit material was distributed as follows: 67 of corrugated metal, 32 of corrugated plastic, 1 of smooth metal, 6 of wood, 7 of concrete, and 8 of mixed materials (any two or more of the materials outlined above). Within the three studied catchments, a total of 45 culverts were found in ‘Acceptable’ condition, 24 in ‘Mediocre’ condition, and 52 in ‘Critical’ condition. In terms of proportion, the three catchments had similar distributions of culvert conditions. We found little difference in the proportion of sites within each overall culvert condition category between those sites found under various landowners, and the sites found within Kenauk Nature private forest. The largest discrepancy occurred within the category of culverts found ‘Acceptable’, where there were proportionally 11% more culverts in ‘Acceptable’ condition in sites under private tenure managed by

FIGURE 2.2 THE DISTRIBUTION OF THE EVALUATED CULVERT SITES IN TERMS OF LAND TENURE (PRIVATE UNDER SOLE MANAGEMENT OF KENAUK NATURE; PRIVATE UNDER VARIOUS LAND MANAGERS; PUBLIC MANAGED BY OUTFITTERS; PUBLIC UNDER UNORGANISED TERRITORIES CLASSIFICATION; PUBLIC MANAGED BY WILDLIFE RESERVES)

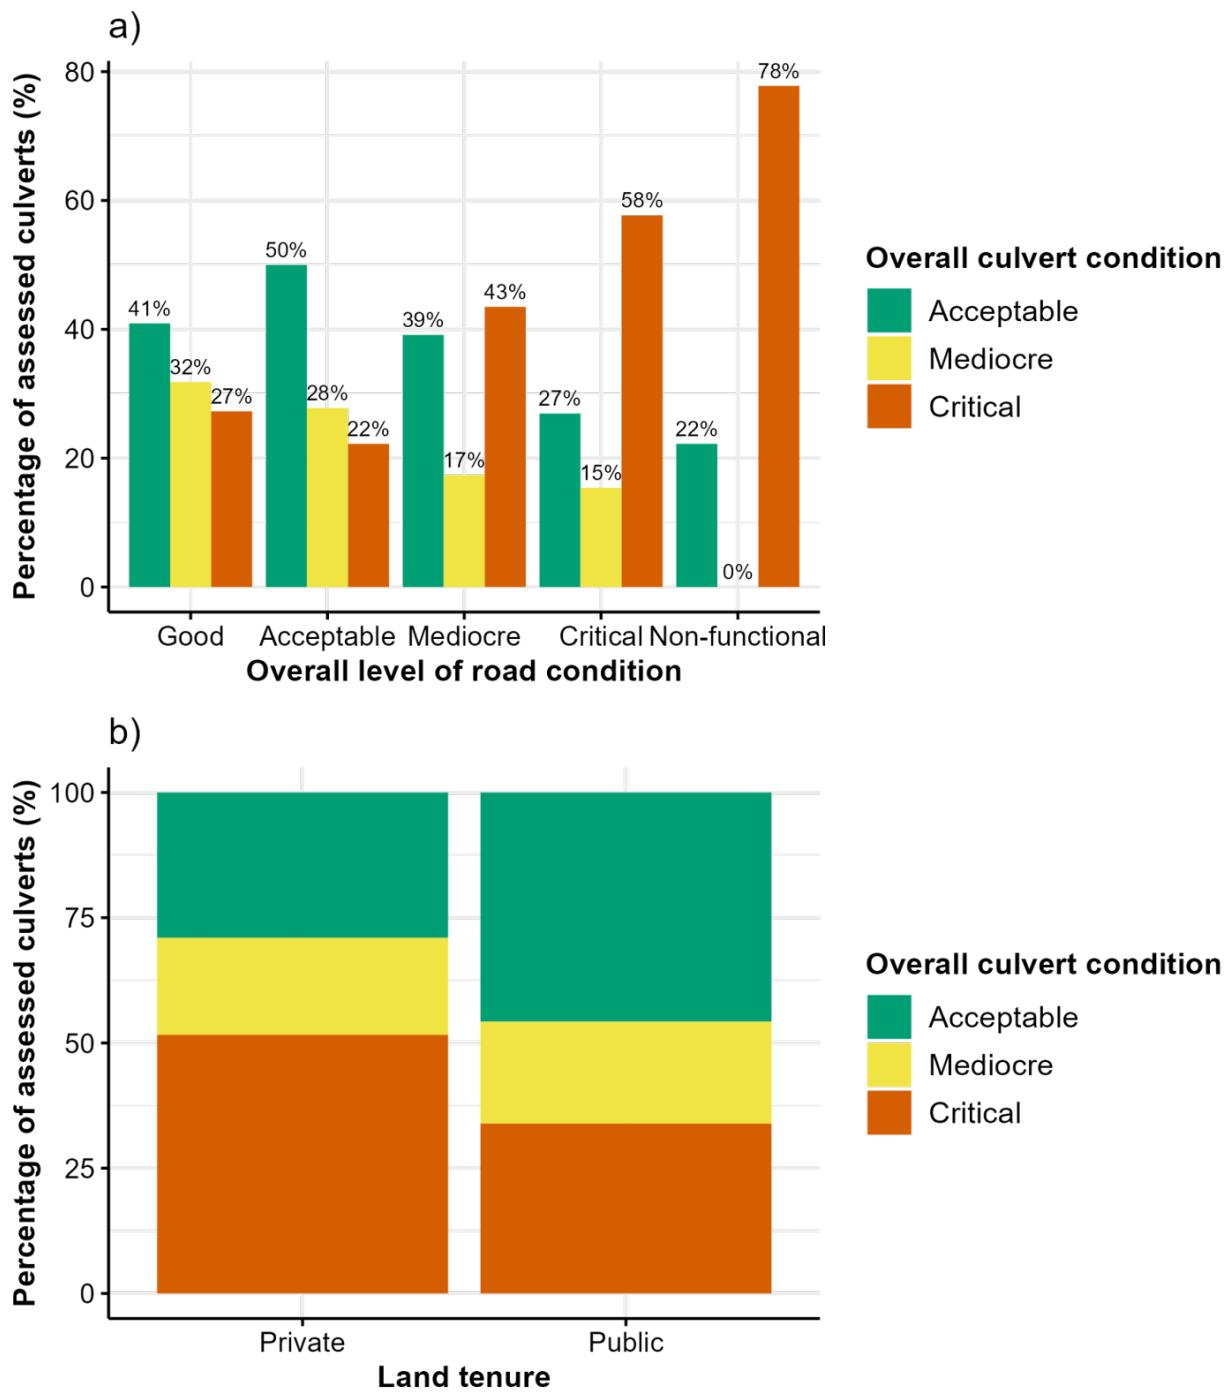
We found a positive relationship between road condition and culvert condition (Table 2.3). As the road condition improves and moves from a higher category (ex: Non-functional) to a lower category (ex: Critical), there was corresponding improvement in overall culvert condition. The majority (78%) of culverts associated with non-functional road conditions were in a critical condition and conversely, culverts in acceptable conditions were predominantly associated with roads in good (41%) or acceptable (50%) conditions (Fig. 2.3a). We also found that land tenure significantly influenced the overall condition of culverts, with culverts on public lands more likely to be found in good condition than those found on private lands (Table 2.3). Overall, 52% of culverts on private lands were in critical condition compared to 34% on public lands (Fig. 2.3b), suggesting important issues with culvert maintenance under both land tenures. The percentage of running lane revegetation was not related to culvert condition and was similar

FIGURE 2.3 PROPORTION OF OBSERVED CULVERT CONDITION ('ACCEPTABLE', 'MEDIocre', AND 'CRITICAL') FOUND A) WITHIN LAND TENURE TYPE ('PUBLIC', 'PRIVATE') AND B) WITHIN LEVEL OF OVERALL ROAD DEGRADATION ('GOOD', 'ACCEPTABLE', 'MEDIocre', 'CRITICAL', 'NON-FUNCTIONAL')

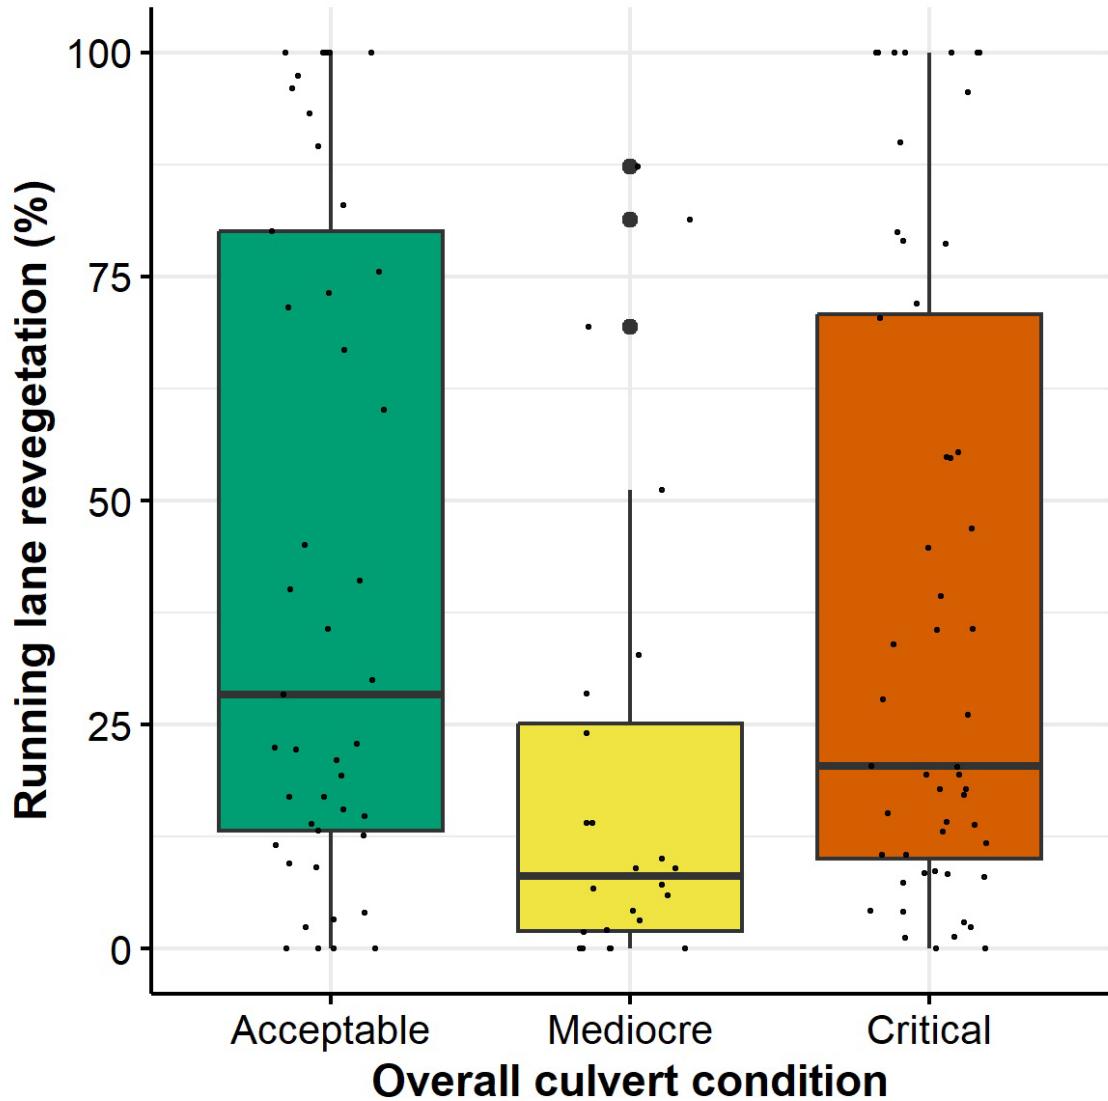
for culverts in ‘Critical’ or ‘Acceptable’ condition. In the ‘Mediocre’ culverts, there are three points with high values, which indicate that culverts in this condition could be associated with higher levels of lane revegetation. However, the overall data distribution in Figure 2.4 suggests that culverts in all conditions can be found on roads with varying levels of maintenance, as represented by lane revegetation. This finding is further supported by the fact that in constructing the final model, the variable *Running lane revegetation* contributed little to the explained variance of the model.

FIGURE 2.4 RELATIONSHIP BETWEEN RUNNING LANE REVEGETATION PERCENTAGE AND THE OVERALL CULVERT CONDITION ('ACCEPTABLE', 'MEDIocre', 'CRITICAL')
